Table 1. Summary of Observed Tsunami Effects

Appendix 2: Summary of Tsunami Observations

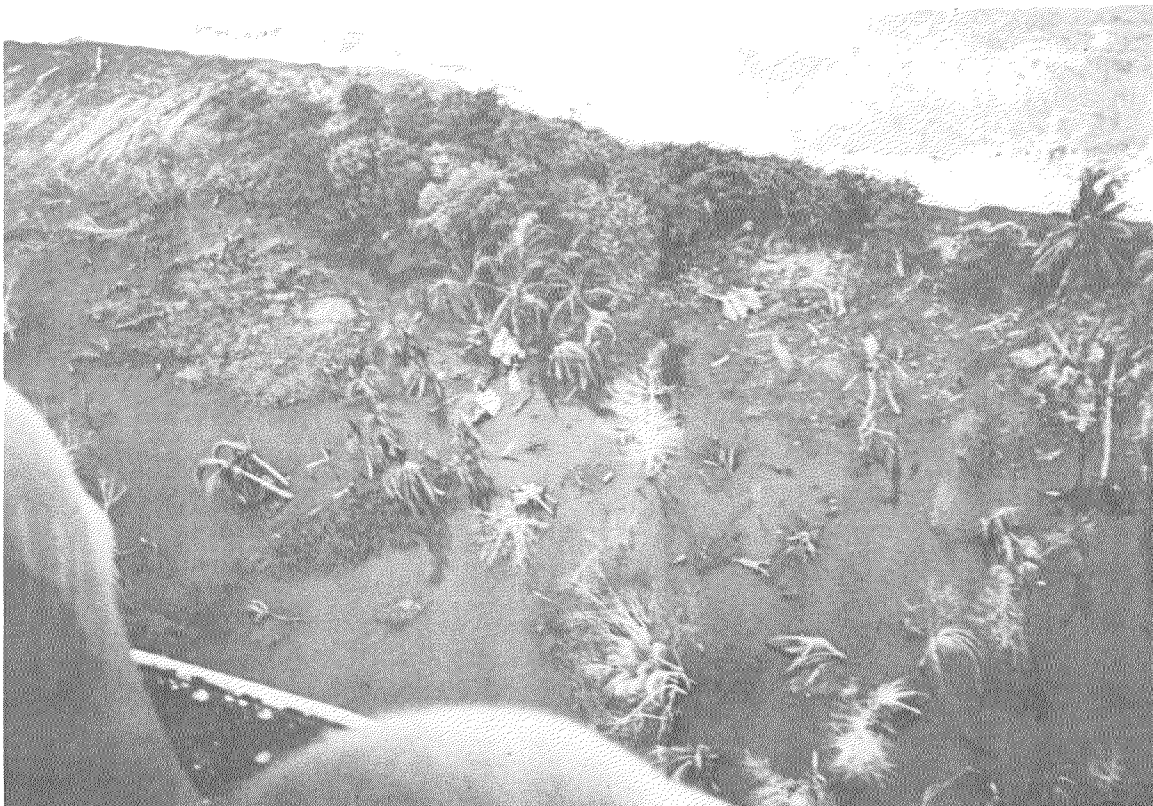
Fig 4.

Beach between the mouth of the River Changuinola and Tiribibi Point (#16 [9.42 N, 82.38 W])- From helicopter view in Figure 4, palm trees and other types of vegetation are seen surrounded by sand. Some deposition structures, presumably caused by a high energy current, can also be seen.
